PHOTOGRAPHIC INTERPRETATION REPORT

**GOLOVCHINO SENSITIVE
OPERATIONS COMPLEX, USSR
OCTOBER 1965**

GOLOVCHINO SENSITIVE OPERATIONS COMPLEX, USSR

OCTOBER 1965

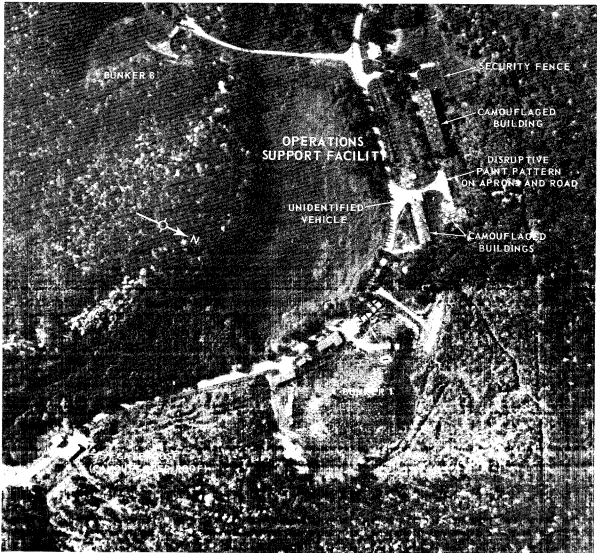
FIGURE 3. OPERATIONS SUPPORT FACILITY, OCTOBER 1965.

Since January 1965, the only significant change in the Operations Area has been an attempt to camouflage several of the prominent features in the Operations Support Facility. A disruptive pattern has been painted on the roofs of the high-bay drive-through building and its 2 associated buildings and on portions of the road and the concrete aprons in that facility (Figure 3). A similar pattern has been painted on the roof of the gatehouse at the entrance to the Operations Area. Because the complex was snow covered in January 1965, it was impossible to determine whether the camouflage had been employed at that time. Although the paint patterns were not distinguishable on small-scale photography of August 1965, the buildings tended to blend into their surroundings; however, road patterns and shadows cast by the buildings were discernible.

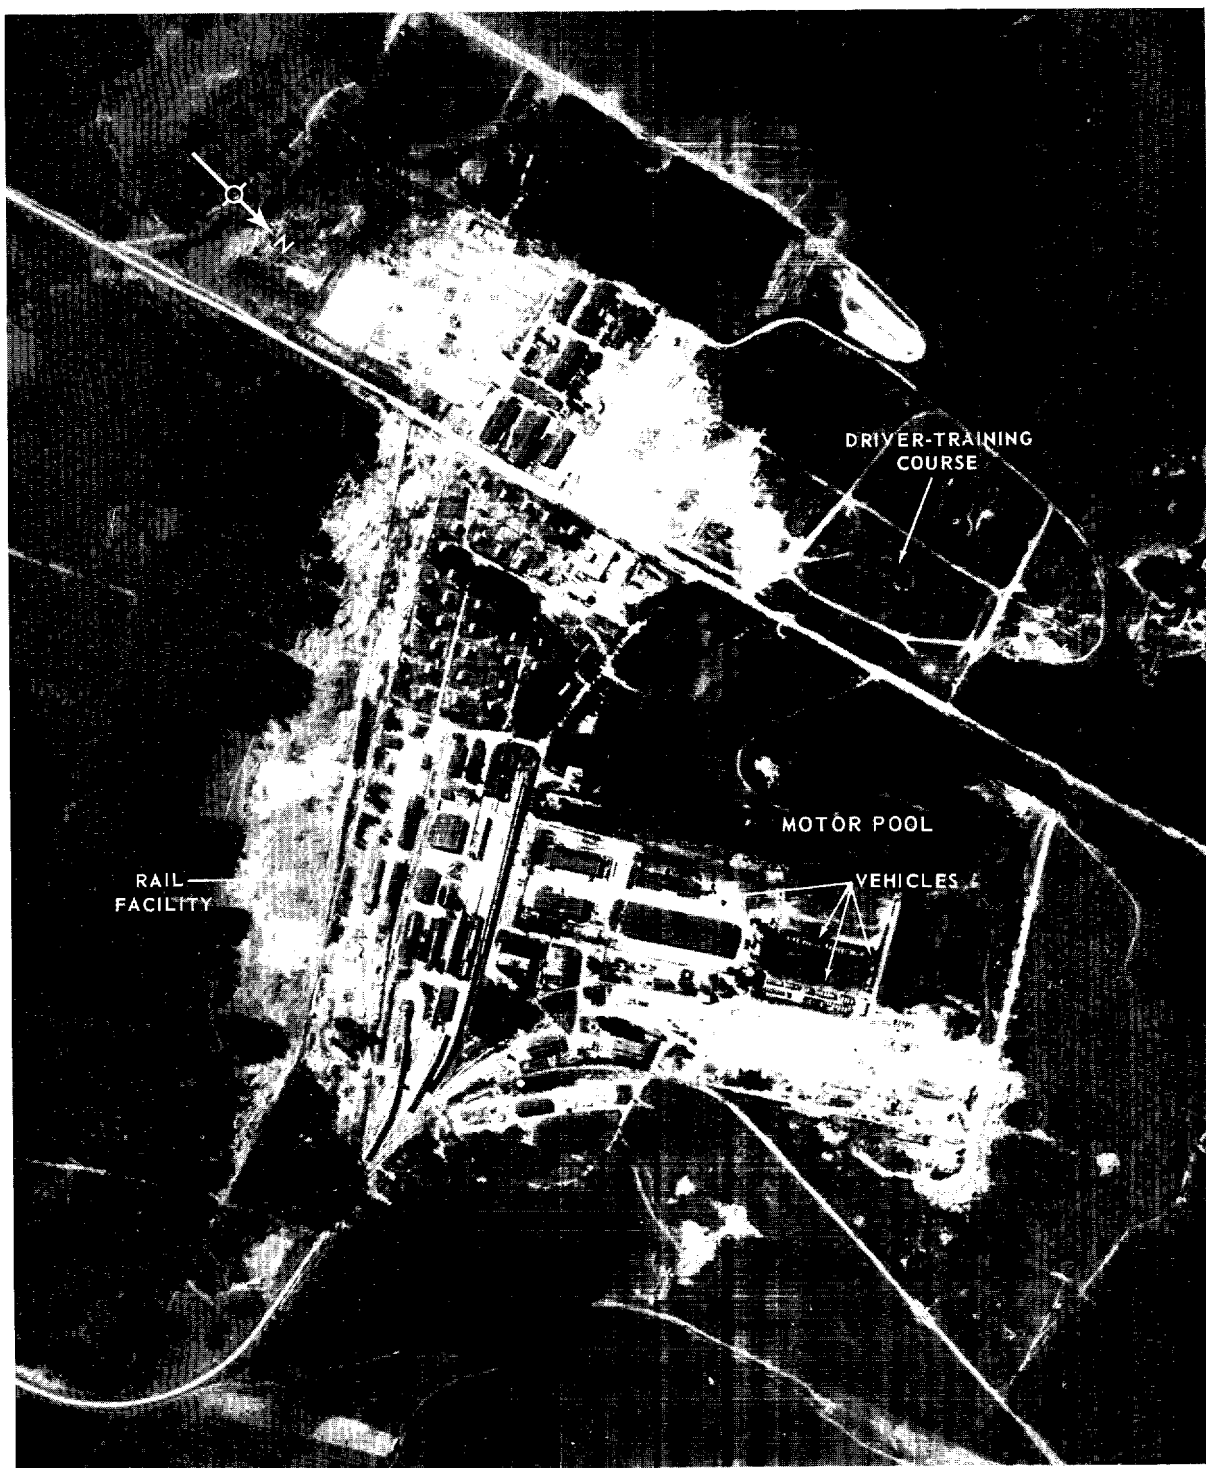
FIGURE 4. RAIL FACILITY AND MOTOR POOL, OCTOBER 1965.

In the Rail Facility a total of 50 rail cars was observed. This total includes 25 cars 12 cars 10 cars 55 feet long, and 3 cars (Figure 4).

In October 1965 a large number of vehicles were parked in the open in the motor pool (Figure 4 and Table 1).

In addition to those listed in Table 1, the following vehicles were also observed: 7 vans with bodies (30 feet long overall, widths unmeasurable), 1 vehicle with a body
